**Lake Christine Burned Area Emergency Response Summary**  
**White River National Forest**  
**July 31, 2018**  
**Prepared by Liz Schnackenberg and Beth Anderson**

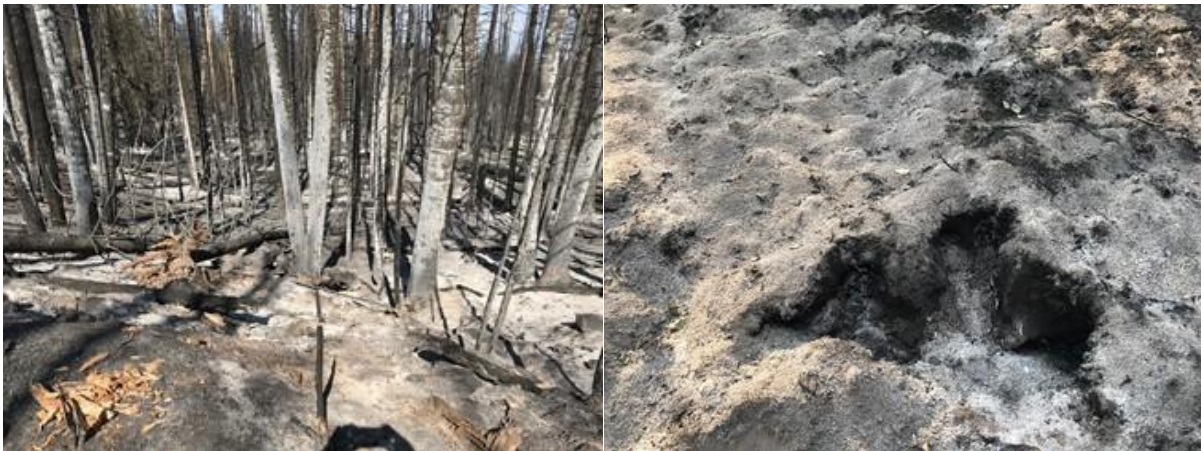
**High Soil Burn Severity in the northern spruce-fir portion**

An estimated 65% of the area within the Lake Christine Fire perimeter had high or moderate SBS and may have developed water repellent soils as a result of the fire. Water repellent soils develop when organic material (dead plant debris) on the soil surface burns during a fire, releasing waxy substances that coat soil particles—basically “shrink-wrapping” the soil and filling in the pores that allow water to soak in during rain events; this condition is referred to as hydrophobicity. When water can’t infiltrate into the soil because the pores are blocked, water runs off over the surface causing erosion and increased flood flow potential.

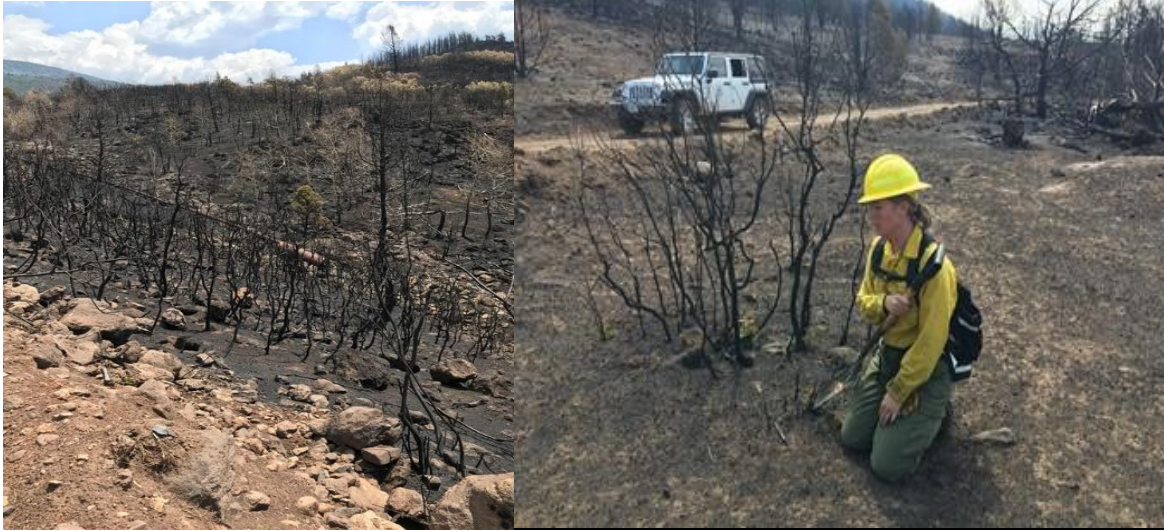
**Moderate-high SBS in the southern portion. Note lack of ash relative to the northern portion**
